USS YORKTOWN CG-48
SEMAT II SHELL CONDITION
ASSESSMENT SURVEY
INTERIOR AREAS
12/02/01 TO 12/14/01

PREPARED BY SUPERVISOR
OF
SHIPBUILDING CONVERSION AND REPAIR
PORTSMOUTH VIRGINIA
12/13/01

14 December 2001
Serial # 1697BA-022

USS YORKTOWN (CG-48)
SHELL CONDITION ASSESSMENT SURVEY, INTERIOR AREAS.

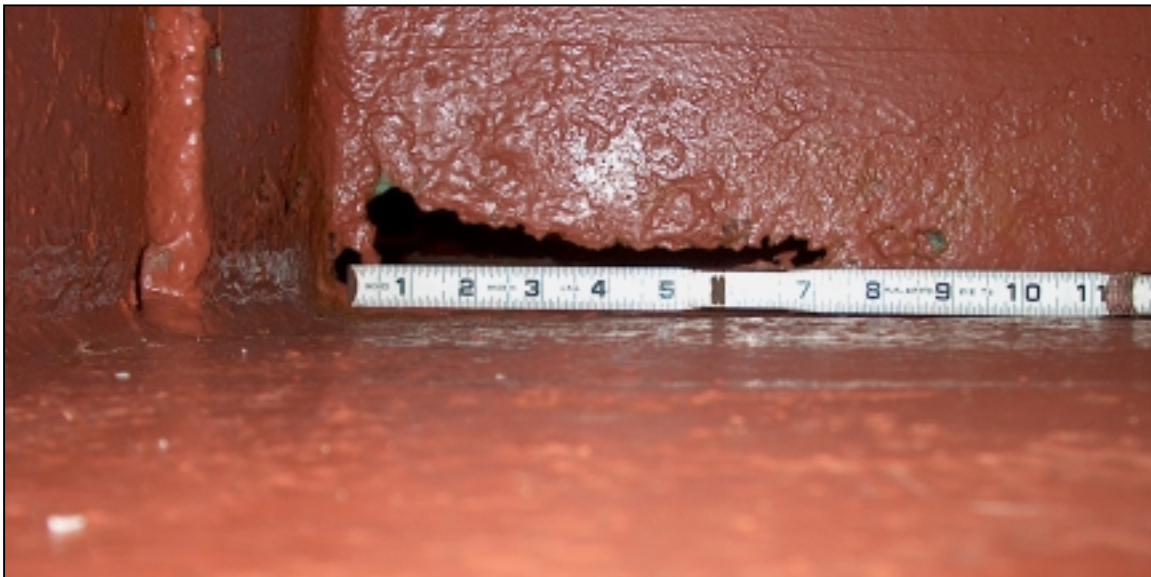
A/C PLANT NO. 1 INBOARD AFT CORNER FOUNDATION IS DETERIORATED WHERE IT MEETS THE DECK

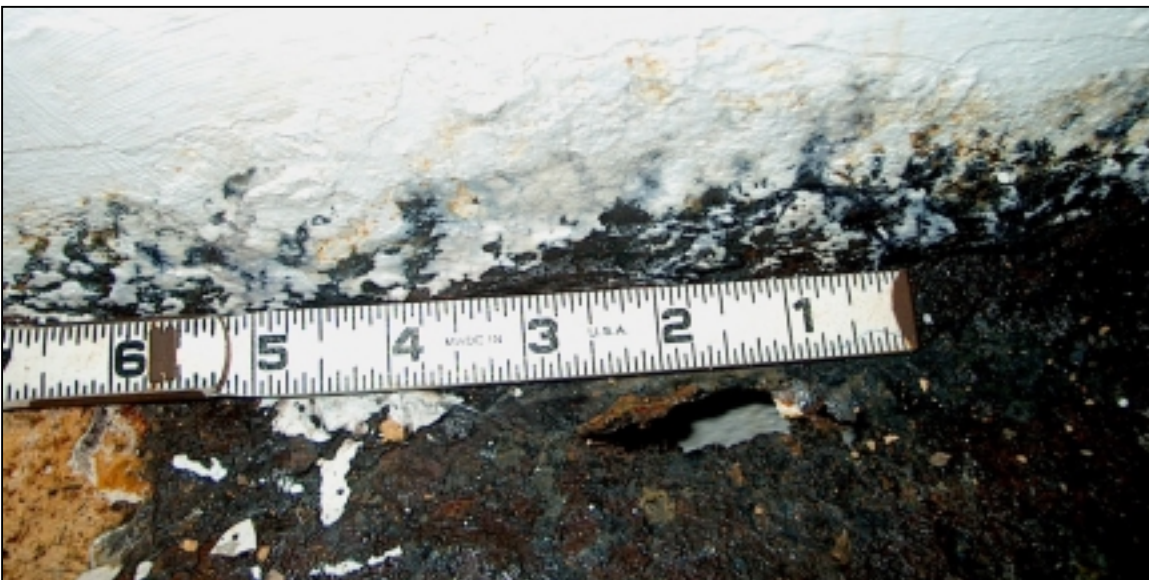
USS YORKTOWN (CG-48)
MAIN ENGINE ROOM NO. 1 (5-174-0-E)
STARBOARD SIDE

HOLES IN WEB OF 6TH STRINGER FROM MARGIN PLATE BETWEEN BHD (220) AND WEB FRAME (212). (CSMP/JSN-3812)

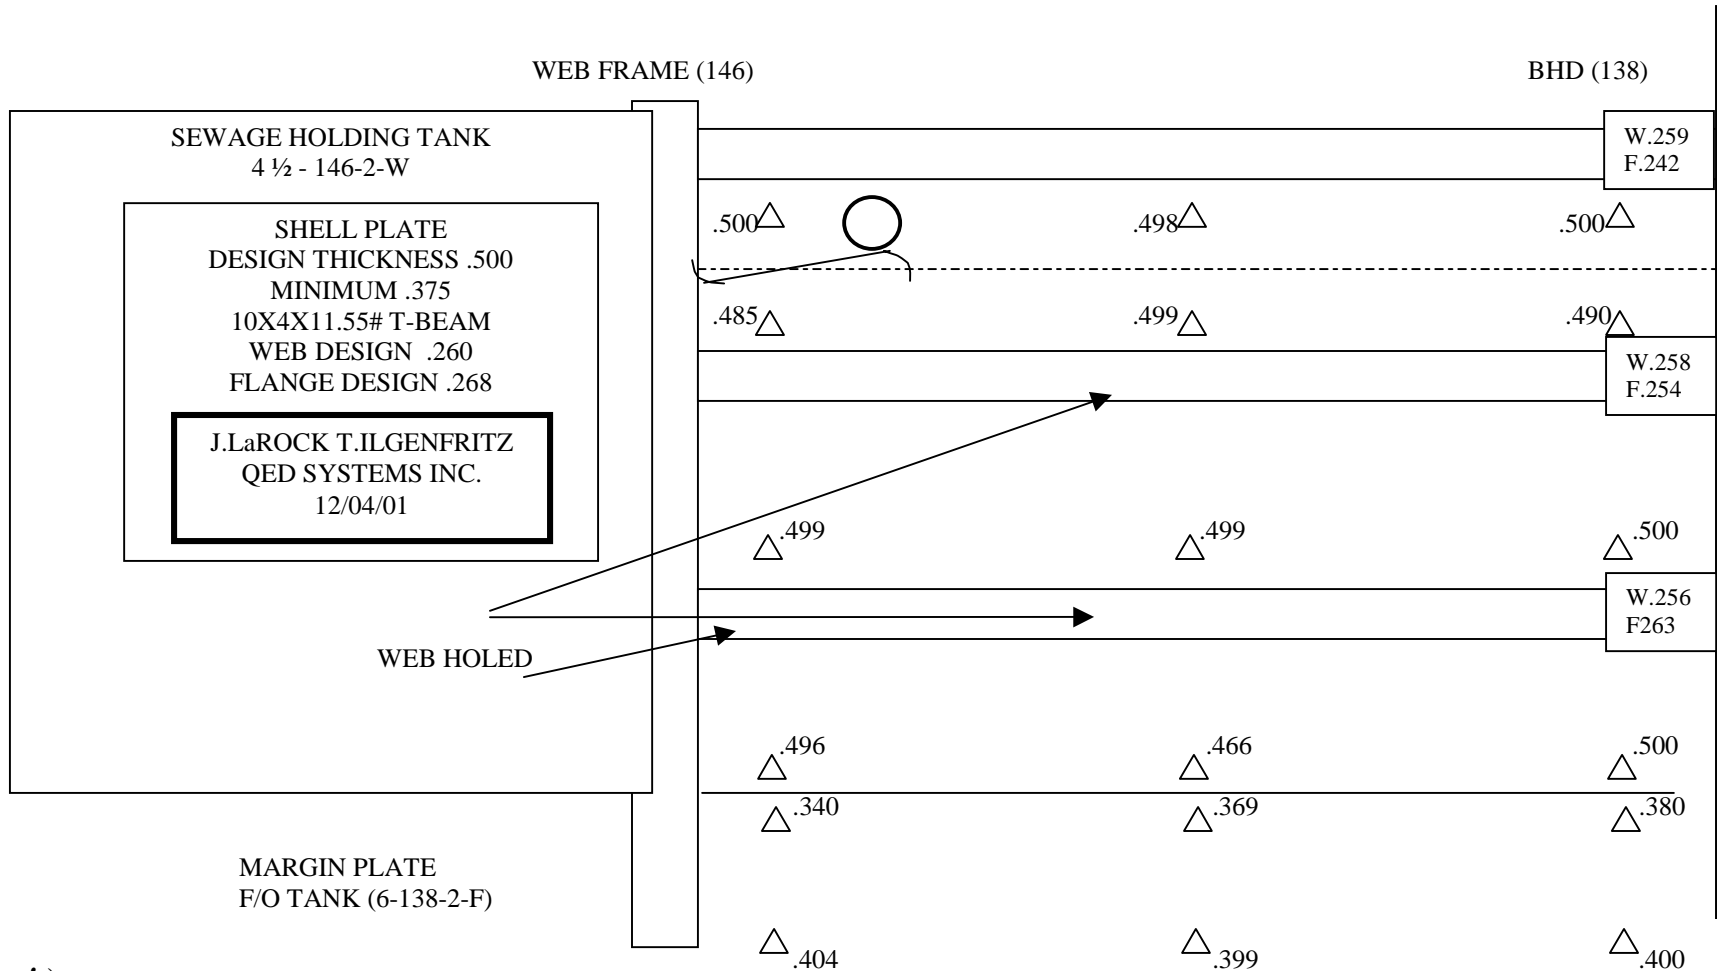
USS YORKTOWN (CG-48)
FORWARD PUMP ROOM / SEWAGE PLANT NO. 1 (5-138-0-E)
PORT SIDE

2ND STRINGER FROM MARGIN PLATE APPROXIMATELY 4 FT AFT OF BHD (138)

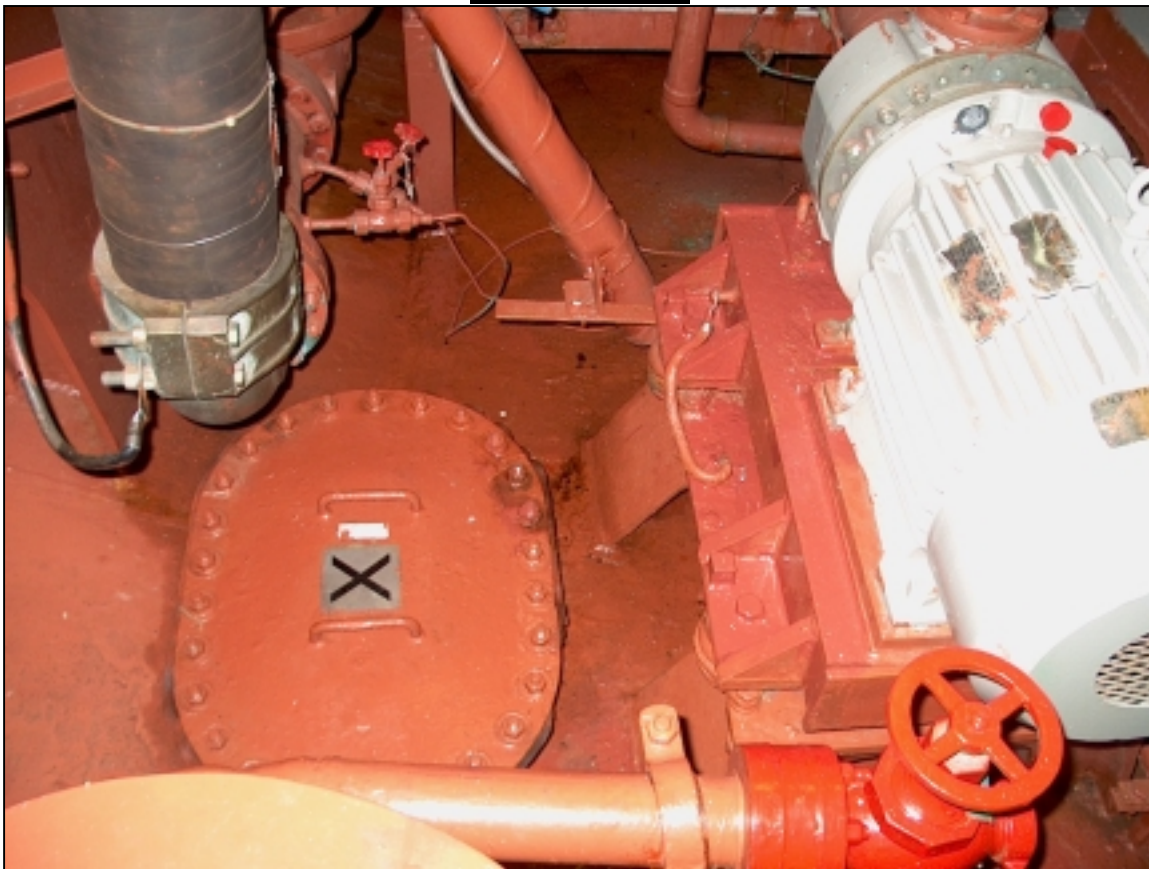
USS YORKTOWN (CG-48)
FORWARD PUMP ROOM / SEWAGE PLANT NO. 1 (5-138-0-E)
CENTER LINE

PIT SWORD AREA CORROSION ON INBOARD SIDE OF F/O TANK (6-138-2-F)

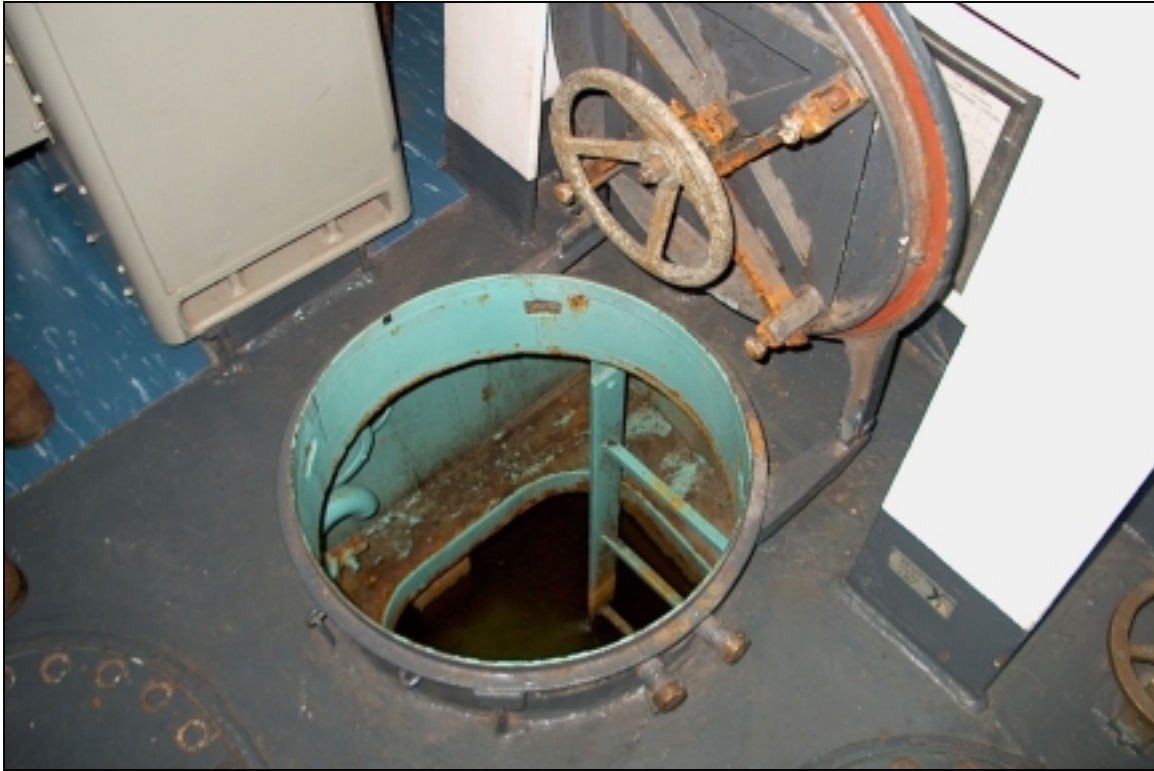
USS YORKTOWN (CG-48)
FORWARD EDUCTOR ROOM (5-34-0-Q)

CSMP SUMMARY: APPROXIMATELY 30 SF OF SURFACE RUST IN EDUCTOR ROOM								TEST# MRC 1102/1		
ROOT CAUSE/AMPLIFICATION: H1								STEP# 1,2,3,4 & 5		
SYSTEM LEVEL IMPACT:										
PART NO.		NOMEMCLATURE				QTY	NSN		COST	
1										
2										
3										
4										
5										
6										
FIRST CONTACT BAILEY		RATE DC1		SECOND CONTACT WATSON			RATE HT1		PHONE	
ASSESSOR / ACT / TECH ID# J. LaROCK/ T. ILGENFRITZ QED SYSTEMS INC.					TD	TL		LOGISTICIAN		TSP

ENTRANCE TO FORWARD EDUCTOR ROOM.

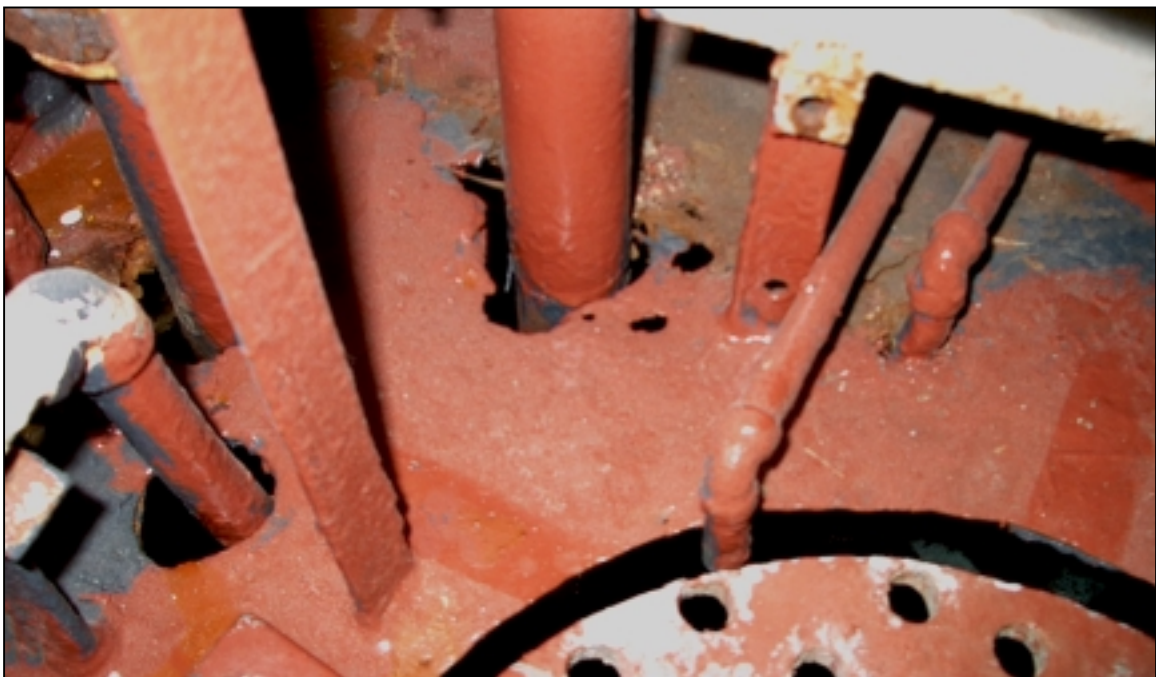
USS YORKTOWN (CG-48)
DOM E EQUIPMENT ROOM (4-58-0-Q)

HEAVY DETERIORATION AROUND EDUCTOR OPENING LOW U/T READINGS WERE
RECORDED IN THIS AREA. (CSMP / JSN-2409)

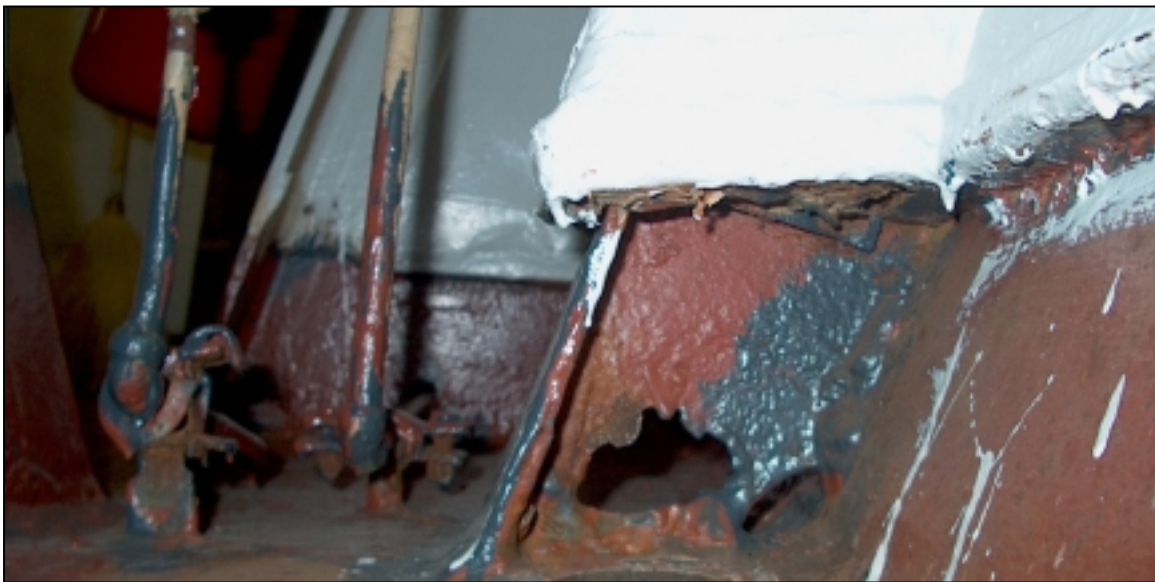
USS YORKTOWN (CG-48)
DOM E EQUIPMENT ROOM (4-58-0-Q)

TANK FILTER (A-F-114). CORRODED WEB IN 5 X 4 VERTICAL STIFFENER APPROXIMATELY
10 FORWARD OF BHD (94)
(CSMP / JSN-2409)
